## Demchyshyn, M.G., and Kril, T.V.

Institute of Geological Sciences, the NAS of Ukraine, 55 b, O. Gonchar St., Kyiv, 01054, Ukraine, +380 44 486 3023, DemchyshynMG@nas.gov.ua

# IMPROVEMENT OF THE ENGINEERING PROTECTION SYSTEMS OF THE KYIV-PECHERSK LAVRA RESERVE TERRITORY

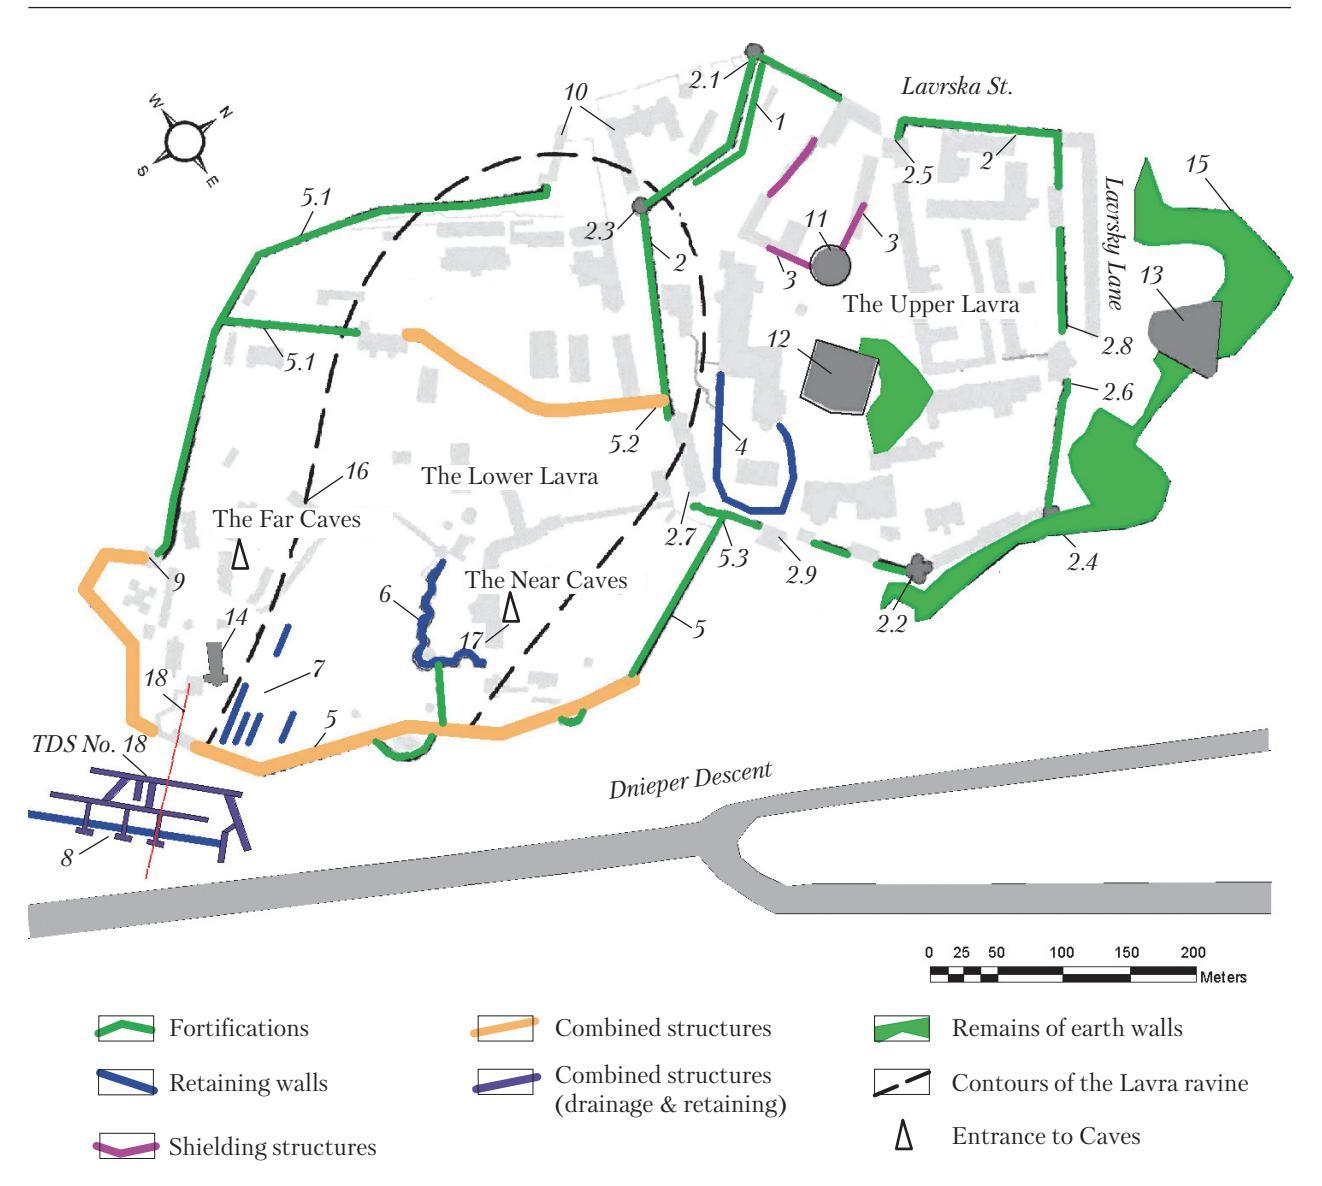
Within the Upper Lavra, the retaining wall with a site, structure No. 30a (Fig. 2, 4), ensures the operation of buildings Nos. 29, 30, and 86. It was erected in the 18<sup>th</sup> century. in order to create a horizontal platform at the level of the Assumption Cathedral, the Belfry, and the Metropolitan's House. The formed terrace was used as an observation deck where, in 1883, an icon-painting school and workshop (building No. 30) were built. The maximum height of its separate sections is 13 m. Today, the wall is in unsatisfactory condition (there are many places with dense crack patterns) and needs to be repaired (reinforcement and restoration of the lining).

On the left side of the Lavra ravine, at the entrance to the Near Caves, the wall of Daniel de Boskette, structure No. 77 (Fig. 2, 6), forms a space for the engineering structures – buildings Nos. 36, 41, and 48. The wall is up to 150 m long and up to 20 m high, has a good architectural design with a rotunda; the width of the wall is about 6.0 m, at the top, and about 8 m, at the bottom. It was designed by military engineer Daniel de Boskette, in 1744–1748, to stabilize the EGPs on the hills, which got intensified as a result of interference in the natural environment: the devastation of forests and the failure of surface and underground drains. Probably, the wall was built not only for retaining the slope, but also for forming a terrace for the placement of religious buildings, in particular, the Church of the Exaltation of the Holy Cross (1700) and the entrance to the Near Caves (building No. 41, 1751). In 2012, the de Bosquet wall had numerous surface damages of the lining (about 40%) and vertical cracks.

**Fig. 2.** Protective and defensive structures of the Upper and the Lower Lavra: 1 - remnants of defensive fortifications; 2 - defensive fortifications of the Upper Lavra; 2.1 - the John Calabytes Tower; 2.2 - the Onufri Tower; 2.3 - the Southern (Clock) Tower; 2.4 - the Northern (Painting) Tower; 2.5 - the Economic Gate with the Church of All Saints; 2.6 - the Western Holy Gate with the Holy Trinity Church; 2.7 - the Southern (Lower) Gate; 2.8 - the Northern Gate; 2.9 - the Eastern Gate; 3 - wall with the gate near the Great Lavra bell tower; 4 - retaining wall of the terrace with observation deck; 5 - defensive walls of the Near and the Far Caves; 5.1 - retaining wall of the  $3^{rd}$  line; 5.2 - the Entrance Gate; 5.3 - the Lower Gate at the entrance to the Near and the Far Caves; 6 - D. de Bosquet retaining wall; 7 - cascade of retaining walls on the right side of the Lavra ravine; 8 - integrated building designed by Peter Suchtelen; 9 - the bell tower in the Far Caves; 10 - the Western Gate with a guard house; 11 - the Lavra bell tower; 12 - the Assumption Cathedral; 13 - the Church of the Savior on Berestove; 14 - the Church of the Conception of St. Anna at the Far Caves; 15 - remnants of the cave field 10 - sectorements of the cave field 10

earth walls; 16 - contours of the Lavra ravine; 17 - the entrance to the cave; 18 - cross section line (see Fig. 4)

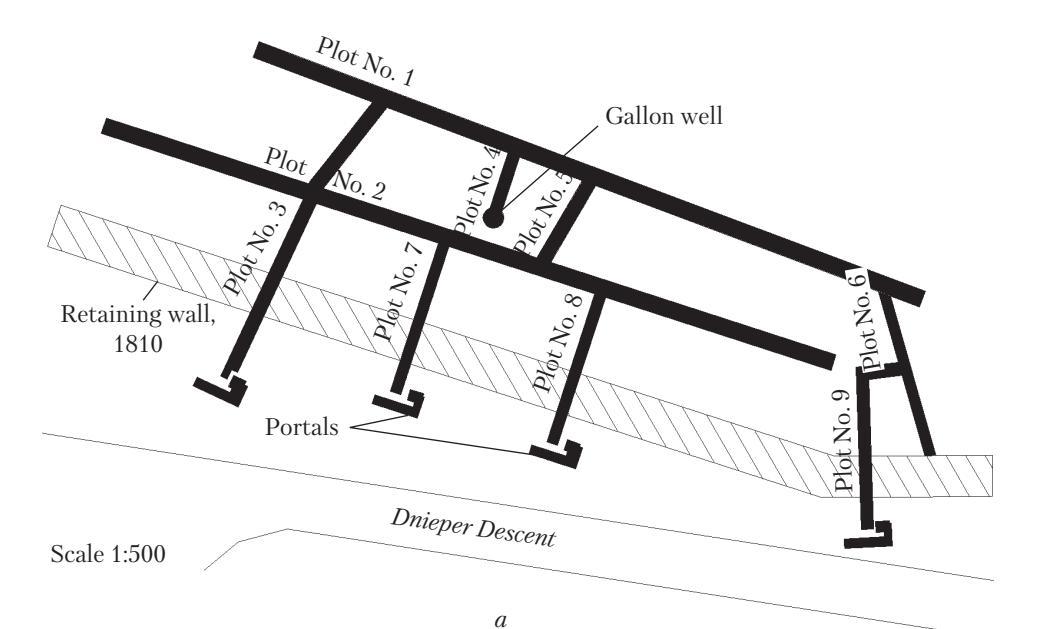
*Fig. 3.* Scheme of the position of the integrated building designed by Peter Suchtelen (TTD-18 and retaining wall) (*a*) and drainage tunnels (*b*)

ness was not as high as expected. The landslides on this slope continued 200 years after the completion of construction works. This is assumed to be caused by improperly arranged surface drainage. Fig. 4 shows a model of the hill with the mentioned engineering structures; their ineffectiveness is explained by unsuitability of the complex for retaining a slope with developing plastic deformations and displacements. In this area, the sediments subject to displacement consist mainly of a fraction of clay rocks, since in the upper part of the slope, there are color and brown clays that are sensitive to meteorological conditions. Therefore, in this case, it is expedient to construct additional surface drainage systems and to properly maintain them.

The artificial drainage for the second aquifer groundwater was firstly used in 1798—1810 by engineer Peter Suchtelen, when an integrated drainage structure was built. It has been preserved to date (partially, as part of the system No. 18, see Figs. 2 and 3). As of today, several tens kilometers of such drainages have been constructed. They were laid in the slope massifs, in some places, in two or even three levels for interception of the Quaternary groundwater aquifers in the Kharkiv formation sands. The drainage is made in the form of trench with a brick collector arranged on piles in such a way as it acts as re-

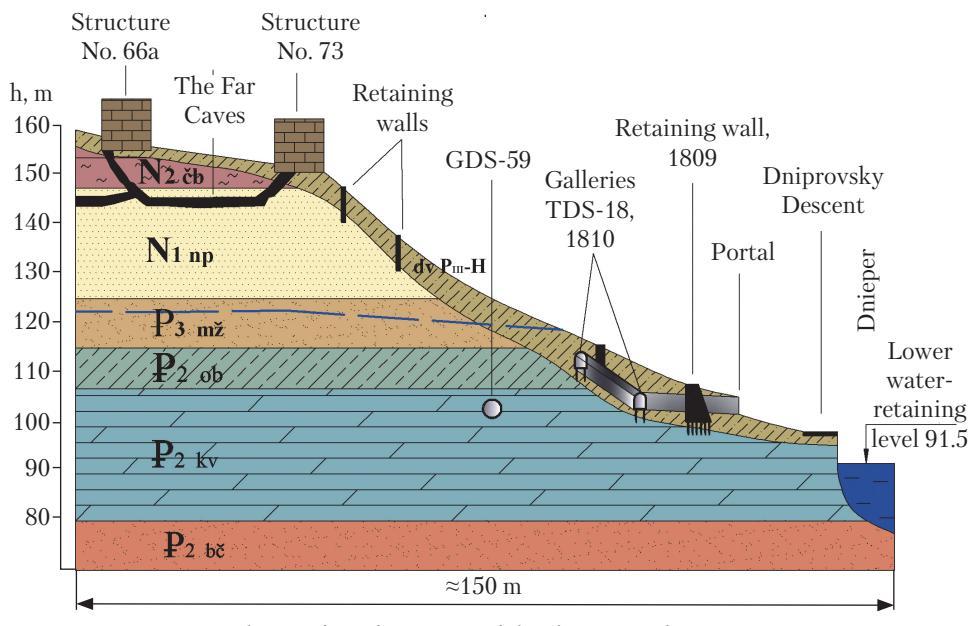
On the right side of the Lavra ravine, in addition to the defensive wall constructed after a big landslide in 1971, which destroyed an almost 100 m long fence at the bottom of the ravine, a cascade of retaining walls (see Figs 2, 7) having a length from 10 to 40 m was built. In 2009–2010, signs of landslide processes were detected [11]: the expansion of cracks in the footpaths along the slopes: the formation of a vertical crack with an opening upward of 6-8 mm in the brickwork (pillar) and cracks of separation from the support of wooden structure in the gallery to the Far Caves; further expansion of bond-failure crack between the curb and the pavement and inclined lantern poles on the edge of the Lavra ravine slope, on the northern side of the building No. 67, etc. The analysis of materials of previous studies has indicated that the localization of these cracks is associated with the landslide of 1971. The nature of slides indicates a long process of soil mass deformation as a result of constant waterlogging and activation of landslides. Deformations and damages of the caves (cracks in the walls, sinks, and overbreaks), in particular, in the Church of the Nativity of Christ, are also likely to be caused by changes in the stability of the soil massif, and, possibly, by the development of deep landslide.

*Fig. 4.* Scheme of reinforcement of the slope near the Lavra ravine (the position of the line of the line in terms of the look fig. 2, p. 18)

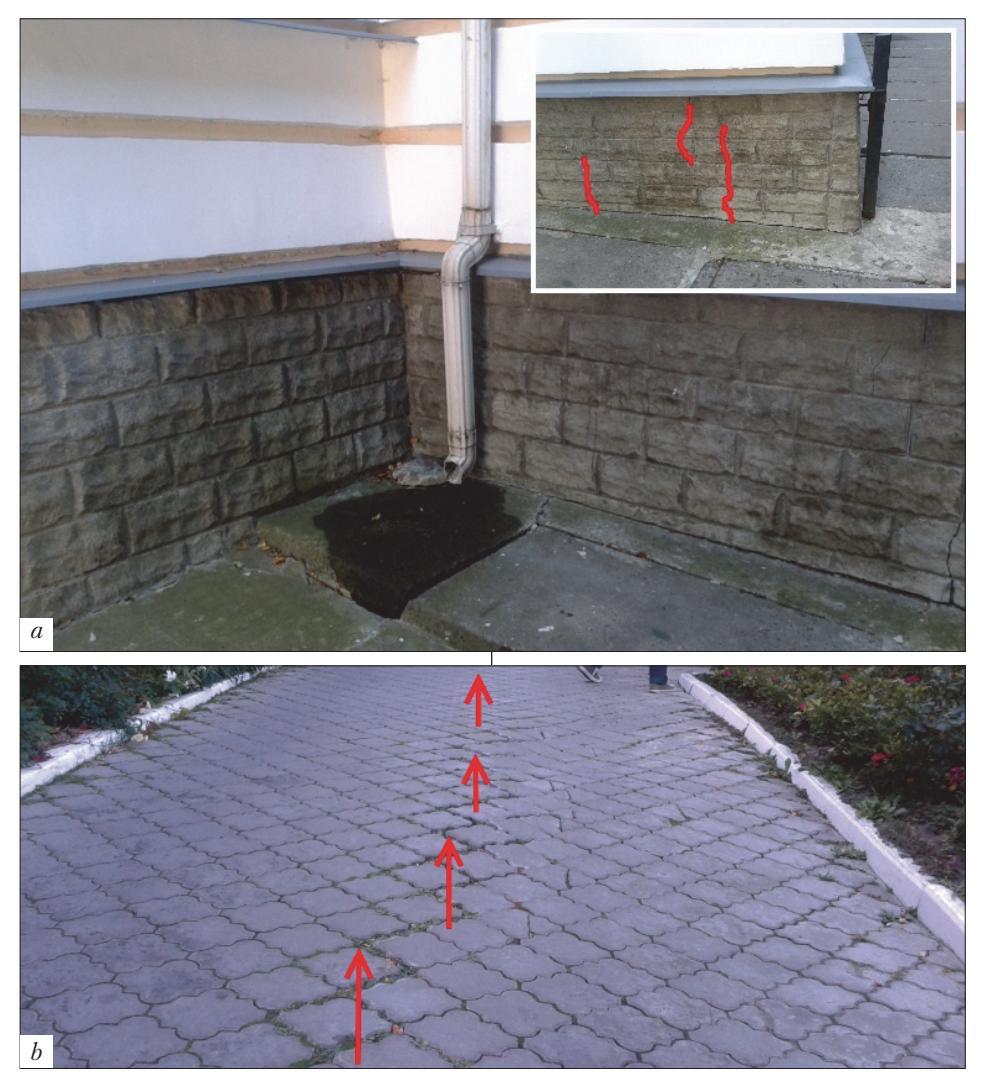
Fig. 5. Deformations of the facing and waterlogging of the foundations of buildings No. 51-52 (a) and swelling of the pavement near them (b). The arrows show the greatest de-

formation

On the Reserve's territory, there is a developed network of shallow tubular rainwater drainages. The densest grid of surface water drainage there is at the Lower Lavra. The intercepted surface waters from there come to shallow brick galleries (No. 1-4) and are discharged to the Dnieper River. Improper maintenance of drain pipes leads to the slaking of foundations of historic buildings and deformations of pedestal faceworks, as shown in Fig. 5

1. To ensure proper maintenance of surface water discharge (the timely repair of chutes, wells, and collectors. Particular attention is needed to the water-supply, sewage, and heating systems, drainpipes and stormwater intakes, which must be cleaned and repaired in a timely manner.
