## Demchyshyn, M.G., and Kril, T.V.

Institute of Geological Sciences, the NAS of Ukraine, 55 b, O. Gonchar St., Kyiv, 01054, Ukraine, +380 44 486 3023, DemchyshynMG@nas.gov.ua

# IMPROVEMENT OF THE ENGINEERING PROTECTION SYSTEMS OF THE KYIV-PECHERSK LAVRA RESERVE TERRITORY

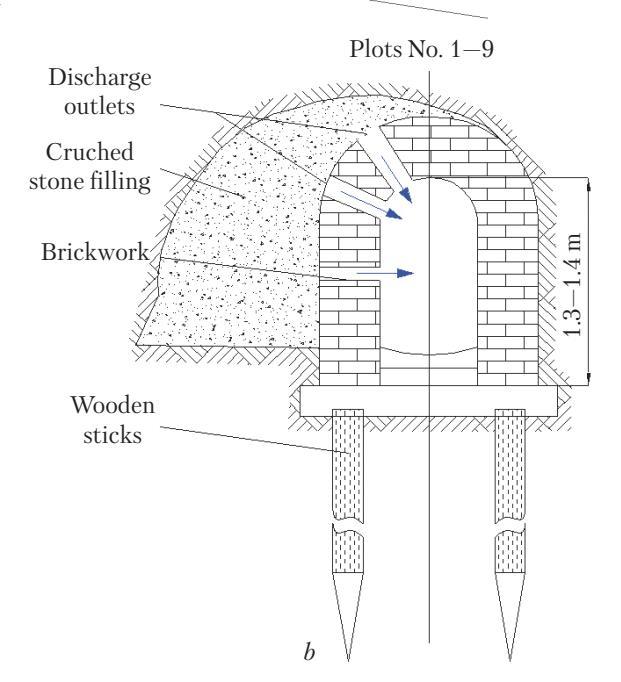
The reinforcement of the right side of the Lavra ravine, near the Far Caves, where the influence of external factors has been evident (caving by the Dnieper River, disturbances of the geological environment caused by the construction of the Rozhdestvensky and the Spassky bastions, in particular, changes of the underground water conditions) required special measures to control the EGP and to retain the slopes. According to literary sources, even Czars (in particular, Alexander I) were engaged in solving the problems of soil stabilization there. To this end, various reinforcement measures were elaborated, among which, the Such telen project - the construction (1810) of a three-tier system: a retaining wall having a width of almost 8 m and two-tier drainages located at different levels (arched structures with an underdrainage for interception of ground waters (Fig. 3) was approved in 1806. These measures are considered the creation of an integrated retaining and drainage structure (Fig. 2, 8).

ness was not as high as expected. The landslides on this slope continued 200 years after the completion of construction works. This is assumed to be caused by improperly arranged surface drainage. Fig. 4 shows a model of the hill with the mentioned engineering structures; their ineffectiveness is explained by unsuitability of the complex for retaining a slope with developing plastic deformations and displacements. In this area, the sediments subject to displacement consist mainly of a fraction of clay rocks, since in the upper part of the slope, there are color and brown clays that are sensitive to meteorological conditions. Therefore, in this case, it is expedient to construct additional surface drainage systems and to properly maintain them.

*Fig. 4.* Scheme of reinforcement of the slope near the Lavra ravine (the position of the line of the line in terms of the look fig. 2, p. 18)
